Aquatic Plant Management Plan

Deer Lake

Polk County, Wisconsin

Draft
May 2023

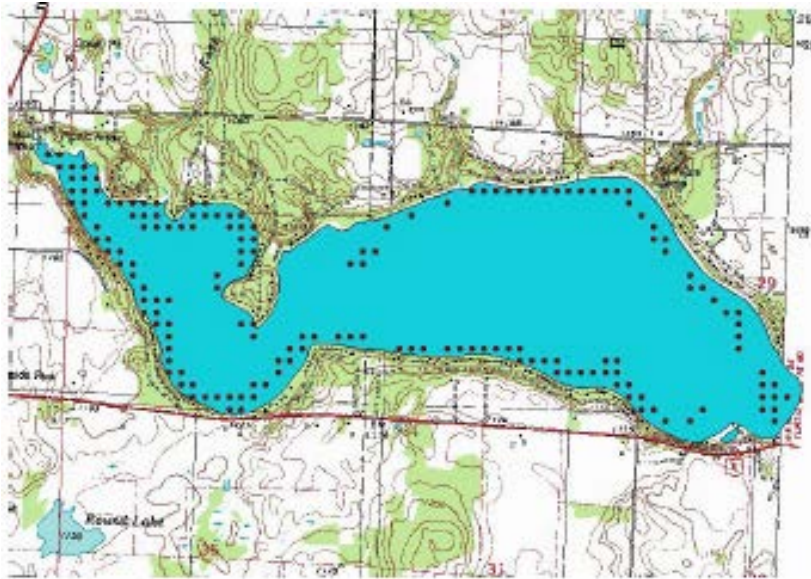
Figure 1. Dominant Sediment Muck

Deer Lake is mesotrophic with July and August secchi depths averaging 15 feet in the East Deep Hole in the past five years (2018-2022). The Deer Lake littoral zone (the depth to which plants grow) reached to 21 feet in 2022. This littoral zone depth is much higher than surrounding lakes in the region because water clarity is high and light penetrates more deeply. Past littoral zone depths were 26 feet in 2016, 28 feet in 2010, 27 feet in 2007, and 24 feet in 2003. The bottom substrate is muck or sand as shown in Figures 1 and 2 below.

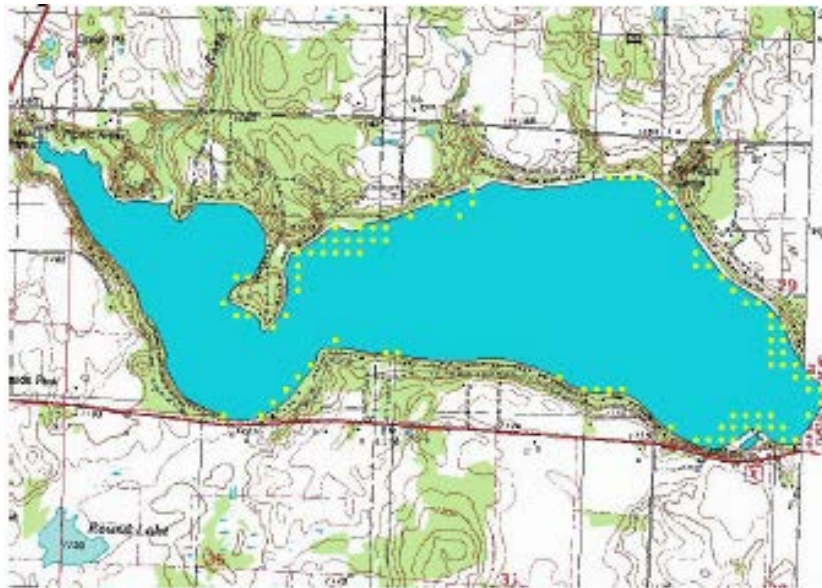
Figure 2. Dominant Sediment Sand

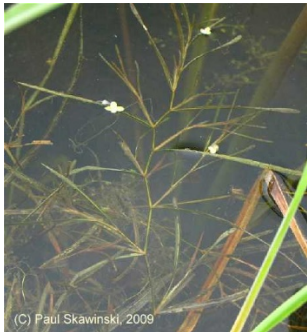
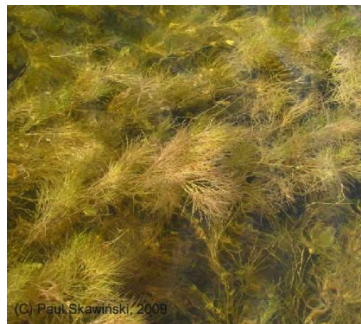
Area C has a range of sediment types from muck to sand and gravel and resulting range of habitats. Chara sp. is common in this area, thriving in a sand substrate. This bay and surrounding area is one of only a few areas that have widespread plant coverage, largely due to shallow water. Common plants include Chara sp., coontail, flat-stem pondweed, northern watermilfoil, and sago pondweed.

Figure 11. Plants present in Area C (left to right): Flat-stem Pondweed, Northern Watermilfoil, and Sago Pondweed

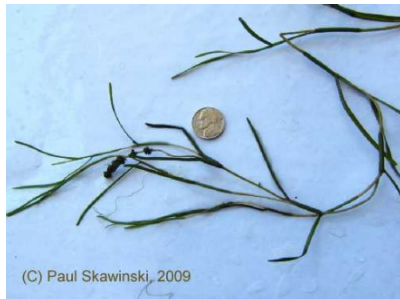
Figure 17. (left to right) Fine-leaved Pondweed (*Stuckenia filiformis*) and Waterwort (*Elatine minima*)

Species	Designation
<i>Stuckenia filiformis</i> -fine-leaved pondweed ⁶	Wisconsin species of special concern
<i>Elatine minima</i> -waterwort	Conservatism value of 9 (10 is the highest)

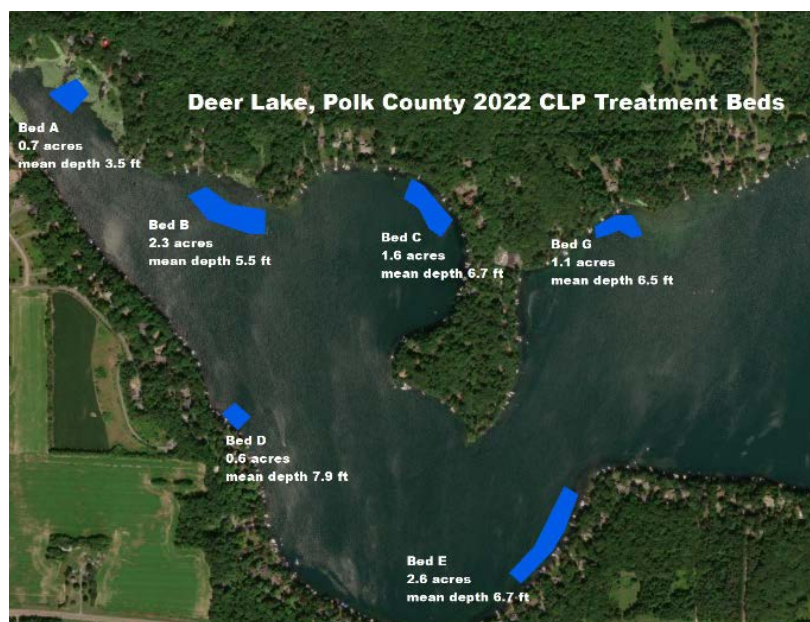
Figure 22. Curly Leaf Pondweed Treatment Areas 2022

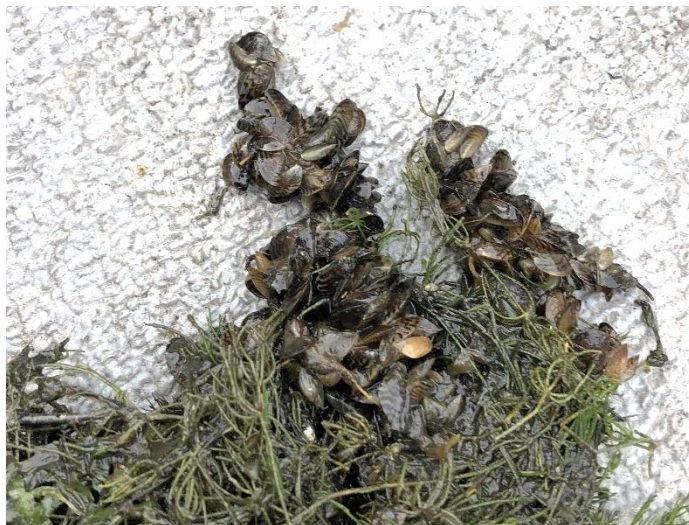
During the summer 2022 aquatic plant survey, numerous plant samples had extensive zebra mussels attached. The most common plant species with zebra mussels was *Chara sp.* Some coontail samples and northern watermilfoil samples also had zebra mussels attached. The frequency of sampling plants with zebra mussels was not recorded, but it was estimated that of the 220 sites with plants, at least 33% of them had zebra mussels. There were also some shallow areas of the lake with dense zebra mussel coverage on the lake bottom (Schieffer, 2022).

Figure 23. Deer Lake Aquatic Plant Sample with Zebra Mussels Attached

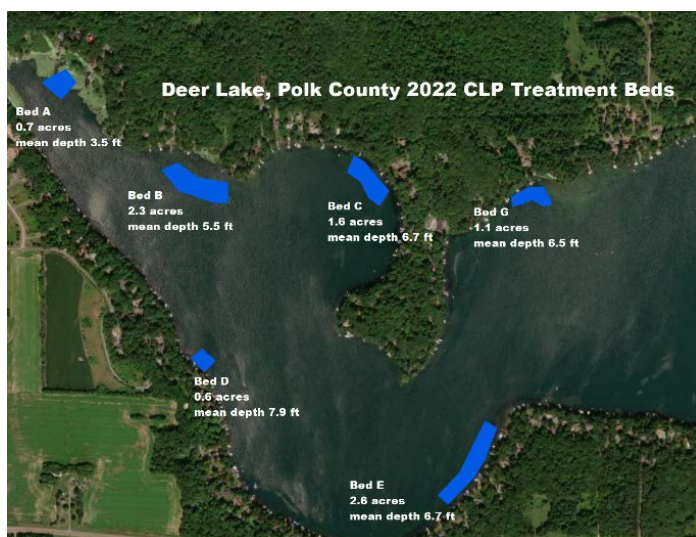
Figure 28. Curly Leaf Pondweed Treatment Areas 2022 (7.6 acres)

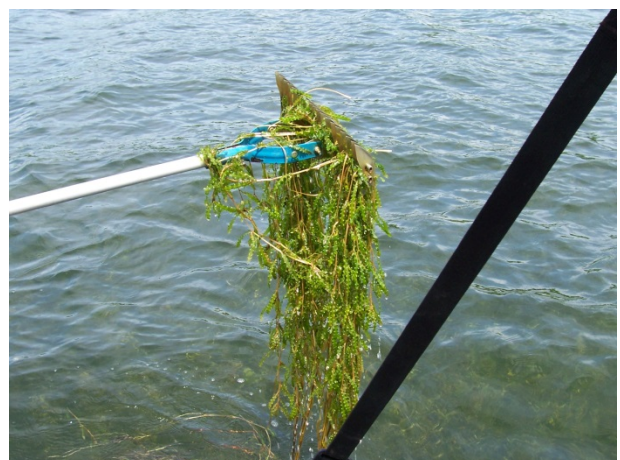
Figure 2: Density rating system and example CLP rake sample.

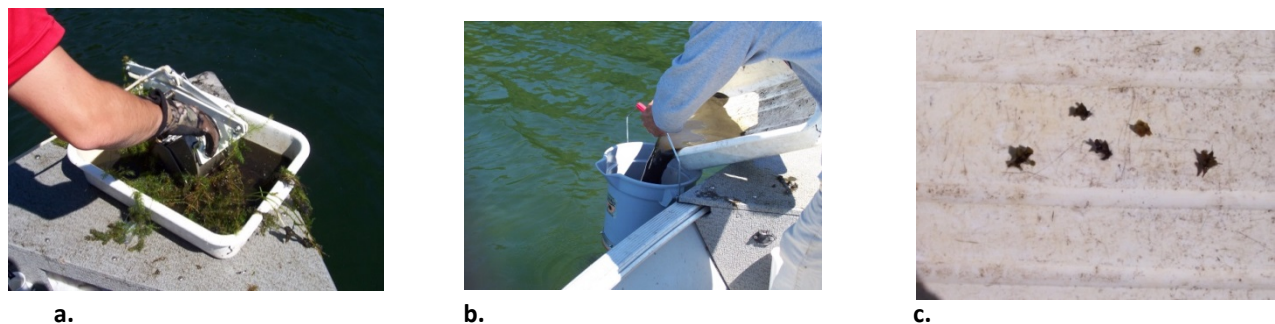
A turion analysis is conducted to reflect further potential future growth and the cumulative success of treatments. This analysis involves going to sample points near the middle of the CLP bed (assuming this will reflect the highest density). At each sample point, a sediment sampler is lowered to the lake sediment, and a sediment sample is obtained. Two samples are obtained from each side of the boat at each location. The samples are then separated with a screened bucket to isolate the turions. The turions are then counted, and the density of turions is calculated in turions/square meter. Consistently successful treatments should show a trend of reduced turion density each year. This way, it is known that the treatments are killing plants before turion production, resulting in an overall reduction in CLP in those beds.

Figure 3: a shows sediment sample; b shows separation; c shows separated turions.
